3RD ANNUAL CONFERENCE

PROCEEDINGS

“CONSERVATION OF BUILDINGS IN URBAN AREAS IN AFRICA TODAY”

**JULIUS NYERERE INTERNATIONAL CONVENTION CENTRE (JNICC)
DAR ES SALAAM, TANZANIA**

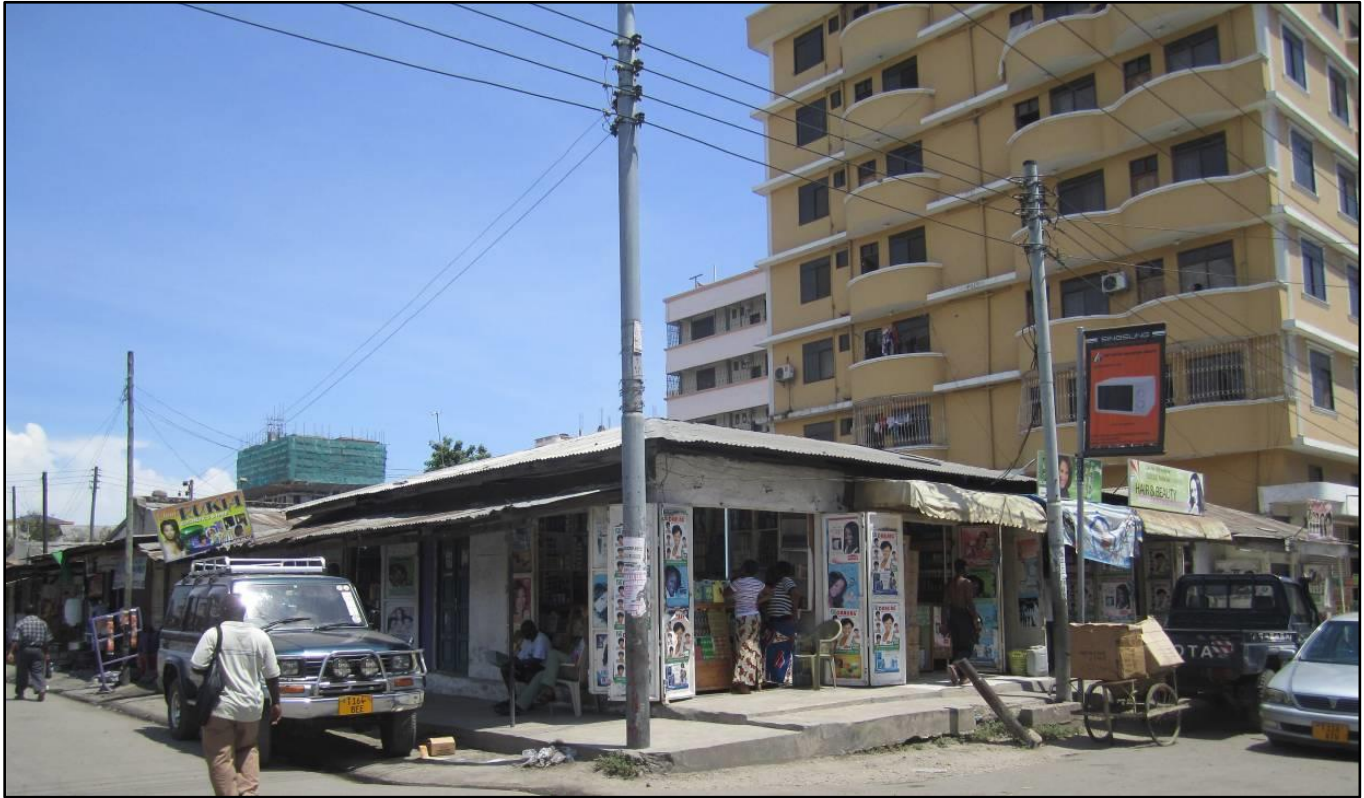
Figure 0.2: Swahili house with an adjacent high modern building in Kariakoo area.

The urban structure is still marked with numerous historic buildings coming from the German period. Nowadays, these buildings are being sacrificed for the demands of commercial, office and residential spaces (see figure 2.1). Old and structurally inadequate buildings are being demolished to make way for new and contemporary ones, better designed for vertical expansion. (CFR cap. 2.1). This leads to a sad loss of many of the city's historical features (see figure 2.2).

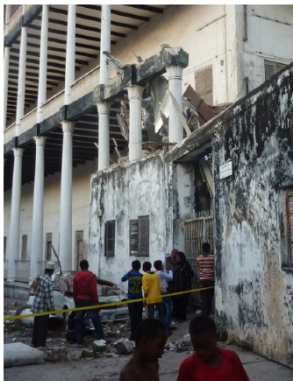
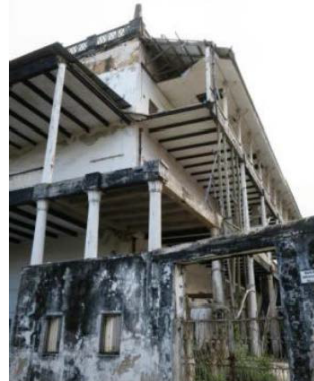
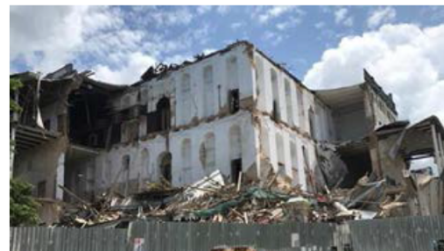
Both monumental buildings over the years have deteriorated due to a lack of frequent maintenance and harsh weather leading to loss of structural integrity and in the case of the House of Wonder, disaster struck more than once. In 2012, a large corner of the building collapsed, in 2015 strong winds caused the partial collapse of the roof and most recently in 2020 when a section of the building partially collapsed.

2012

2015

2020

Unfortunately, the House of Wonders was left without repair for a long time. Its back side partly collapsed in 2012 followed by its western wing in 2015. These warning collapses were signs of a more serious emanating fall that in 2021 the larger front portion and inner core including its splendid observatory tower went down in a surprise (Fig. 5). Sadly its largest front door (Fig. 6) astonishing every visitor was completely destroyed and the supporting columns were overwhelmed by the heavy rubble masses that they were also broken into pieces.

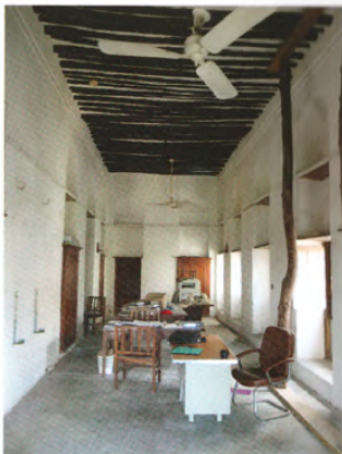
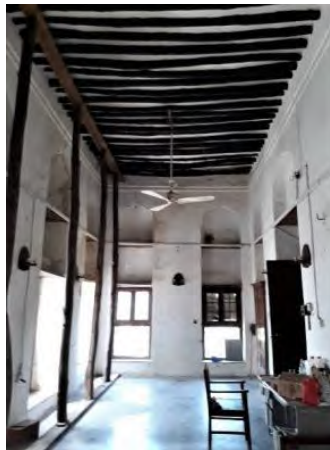
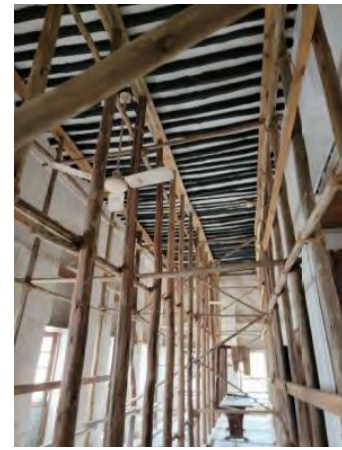
For the palace museum, the majority of the deterioration has been on the building surfaces with visible decay and structural integrity of the members compromised that props have been put in place to keep the building from collapsing. The series of images below show the extent of deterioration over the years from documentation collected.

2015

2019

2022

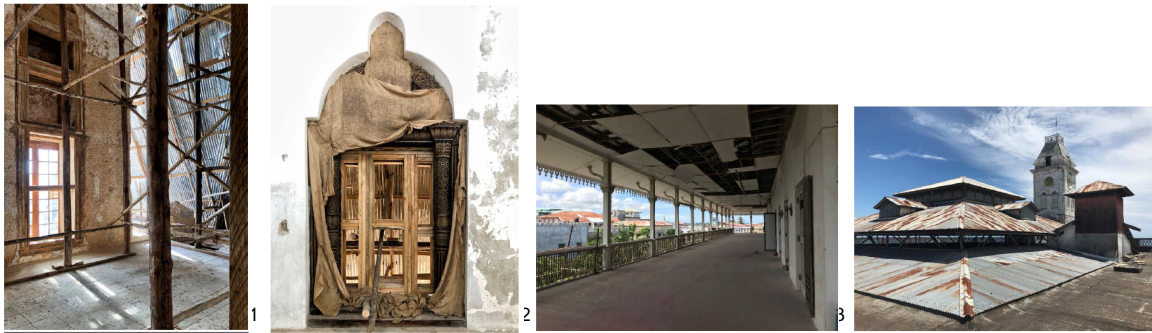
Using the case study – House of Wonders as precedence, the approach involved carrying out a conditional survey to analyse and determine the extent of the damage in order to propose feasible solutions in line with the remedial measures. This focused extensively on the original construction principles and technology used under the elements of walling, balconies, roofing and finishes.

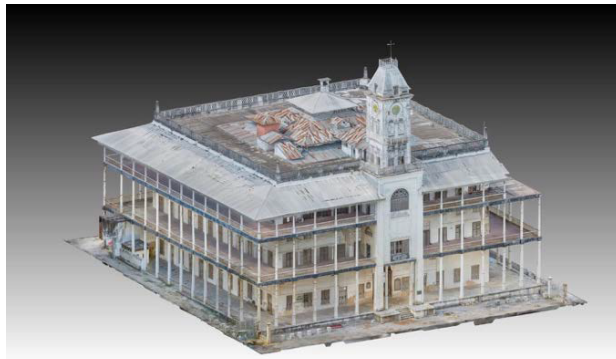
(i) Laser scanning and 3D photogrammetry survey

Led by Prof. Heinz Ruther, this 3D data collection mission was carried out by a group of experts from the University of Cape Town (South Africa) in association with the Zamani Project from January 2021 to February 2021. The team built-up on previous results from a survey undertaken by Zamani Project in August 2019 and established a new virtual model.

The team accurately recorded the pre- and post- collapse geometry of the walls, columns and other key physical features of the building.

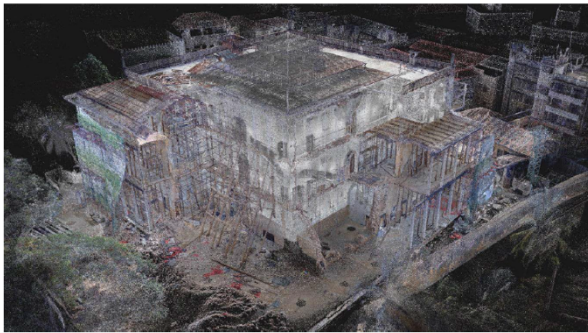
A report prepared concluded that the deformations due to the collapse of the building are limited to certain areas. The established documentation can be used to monitor the status of the building in order to detect and quantify any changes and/or deformations in the building structures during rehabilitation

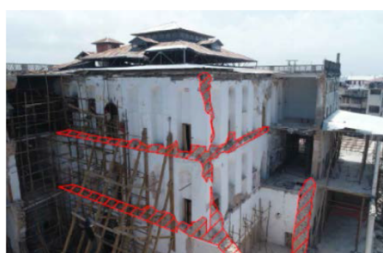
(ii) On site assessment of the structural damage

An in-depth assessment of the building was carried out by a team of architects and structural engineers.

In November 2020, Ingenuity Works carried out a geotechnical investigation for the regeneration of the House of Wonders. The team drilled six boreholes of varying depths around the building and collected samples that were taken to the laboratory to test the degree of corrosiveness due to the presence of chloride and sulphates in the area. They also performed an in-situ Standard Penetration Test to determine the soil bearing capacity.

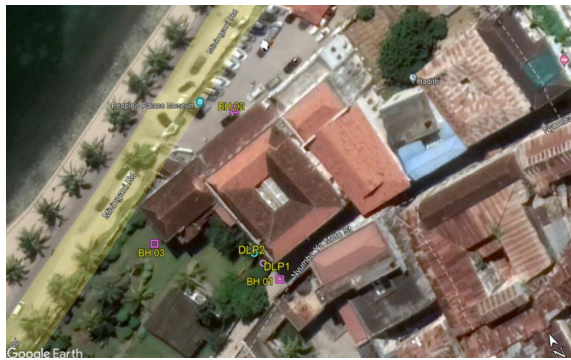
(ii) On site assessment of the structural damage

The on-site assessment was carried out by architects and engineers to determine the extent of damages to the Museum.

The structural engineers assessed the buildings foundations, walls, floors conditions, emergency supporting props used for shoring the walls to prevent collapse. They drilled 10 metres boreholes at three locations around the building, took disturbed and undisturbed soil samples for testing in the laboratories.

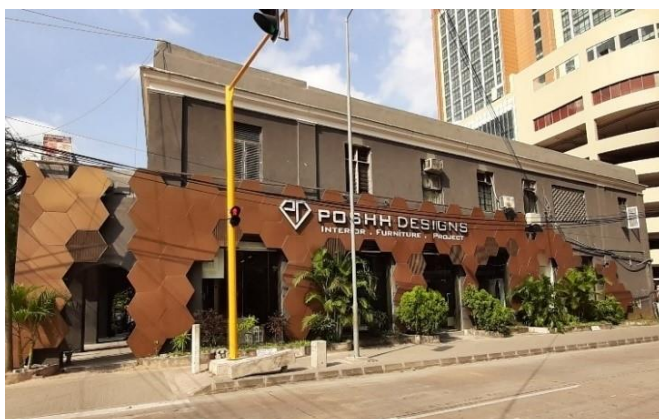
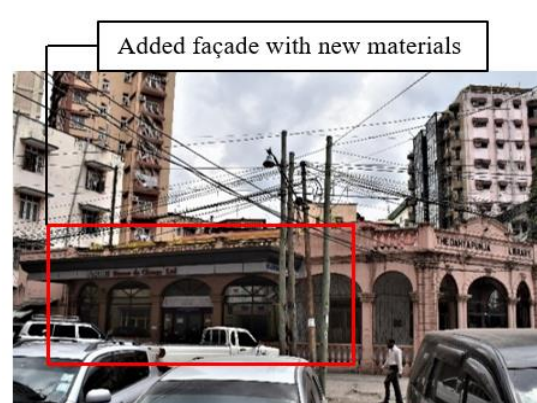
Figure 2. (a) Building at the corner between Samora Avenue and Morogoro Road with facades changed to accommodate current functions. (b) Dahya Punja Library built in 1928 for Gujarat community at the corner of Indira Gandhi St. and India St. with parts of facades changed to modern materials. (Source: Author,2020).

Physical transformation in this study includes changes in facades in terms of colors, additions and removal of structures and objects which were available when the building was built. Due to the influence of urbanization, historical buildings have been altered to fit with functions assigned to them due to new needs caused by urbanization (refer to Figures 2 and 3). The needs include residential, office and commercial space.

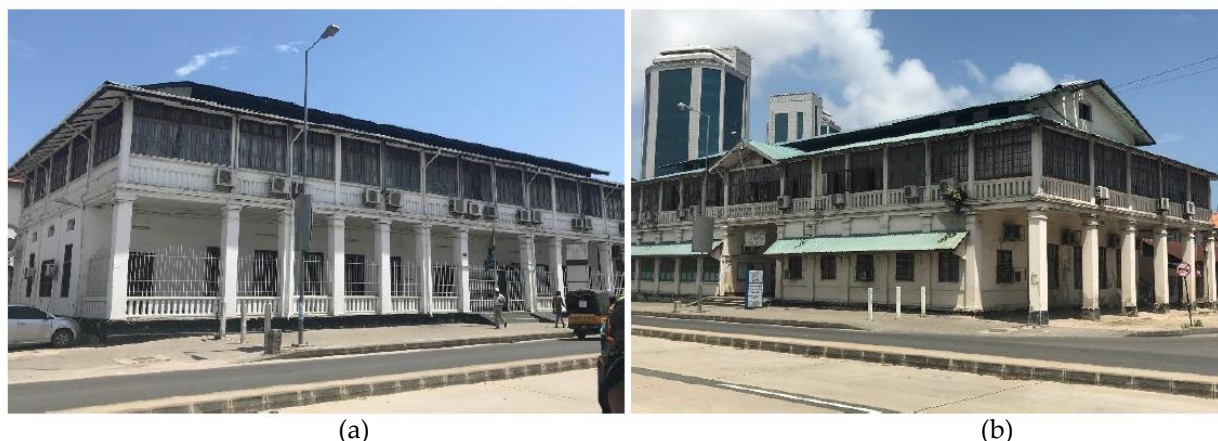
Figure 3. (a) NBS building (b) Survey and Mapping Division building; Series of German buildings with balconies covered to increase the floor plan area. (Source: Author, 2020).

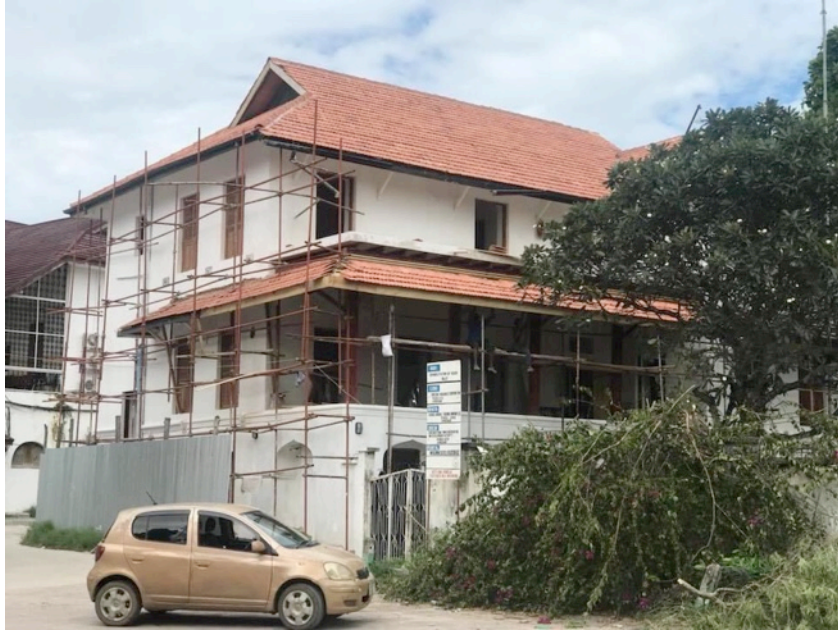
Sinclair; a Marine Engineer who designed and construct several monuments in the Stone Town. The original construction of this house employed traditional materials; rubble stone walls and mangrove poles supporting floor decks, typical of the STZ buildings. The original owner could not be obtained but several other people had occupied the building. It was used as a German Consulate and quite recently before substantial renovation works it hosted Egyptian Consulate. It is now owned by an insurance company. The 1920 renovation introduce dramatic change to the building. Lime and pebbles concrete with wire mesh replaced the stone and *boriti* construction. It also introduced I-beams to provide larger spans. Hardwood timber was used to inclose the I-beams but was now found decayed.

Figure 1: House No. 13 before recent renovations (Curtesy of Abuu Shani)

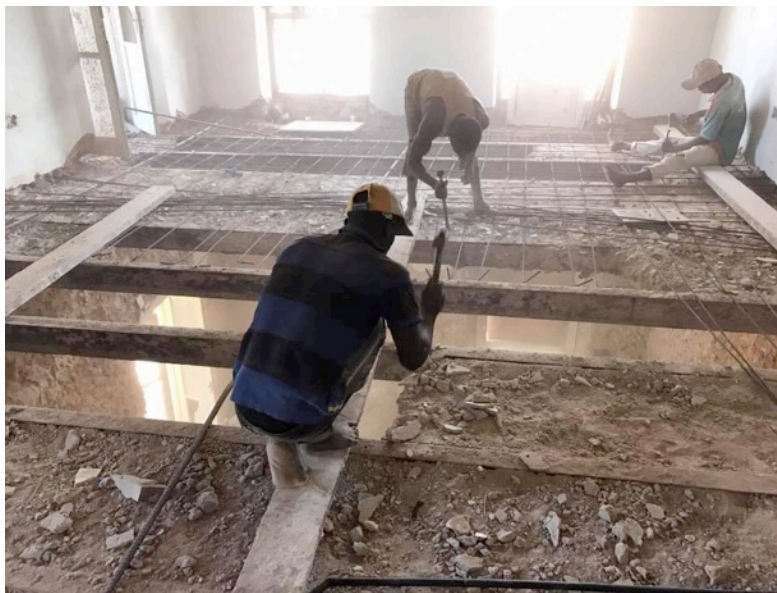
The event above prompted to rethink the renovation plan and used as a proof of deterioration. Although the plan proposed minor repair to the floor, the unveiling situation demanded structural replacement of the entire building floors (Fig. 2). A team work approach was used to share experience on how to redesign the floors based on conservation rules, buildability issues, meeting safety standards, and yet affordable to the Client. In most cases, the team is forced to provide new solutions to suit the situation. A consensus was reached, however, although the most effective option was chosen, the solution contributed significantly to the overall project cost which went from 372 million to some 950 million shillings; an addition of 61% to the initial budgeted cost.

Figure 2: Replacement of structural floor slab during renovations (Courtesy of Abuu Shani).

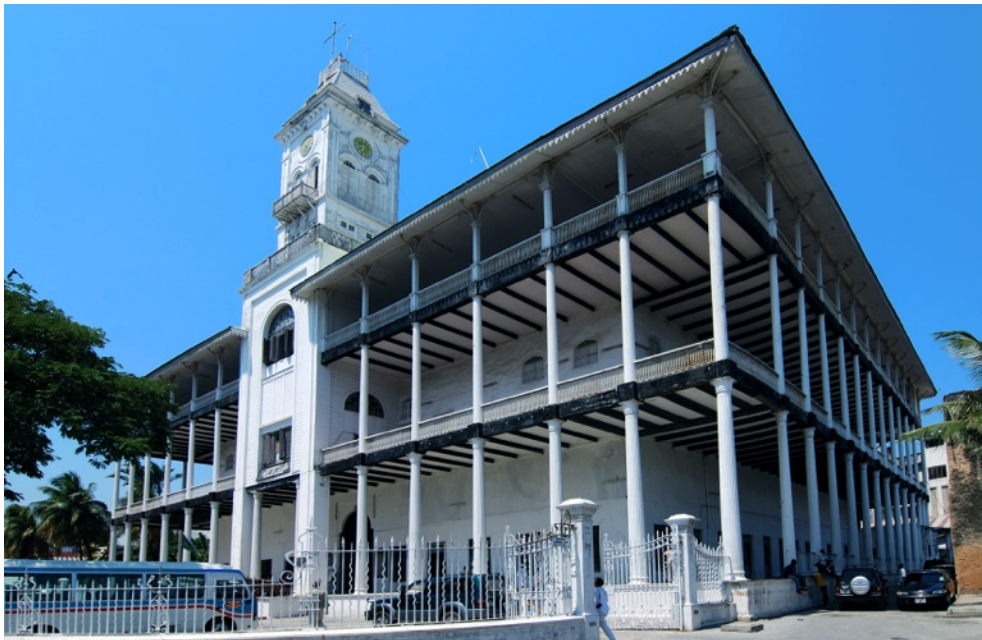
Constructed along the sea promenade overlooking Forodhani Gardens in 1883 (139 years ago) by Sultan Baragash bin Said, the House of Wonders (Fig. 3) is the most imposing structure in the STZ. It is so named partly because of its grand size but also due to the fact that it is the first building of its kind in sub-saharan Africa. By the time it was installed with electricity, tap water, and an elevator. The building consists of wide verandah surrounding the inner core. The ground floor is 7 meters high while the first and second floors are respectively 6.8, and 6.5 meters. House of Wonders was used as a ceremonial palace during the Sultan's reign.

Figure 3: House of Wonders before collapse (left) and after recent collapse (right) (Courtesy of Rao Jodha).

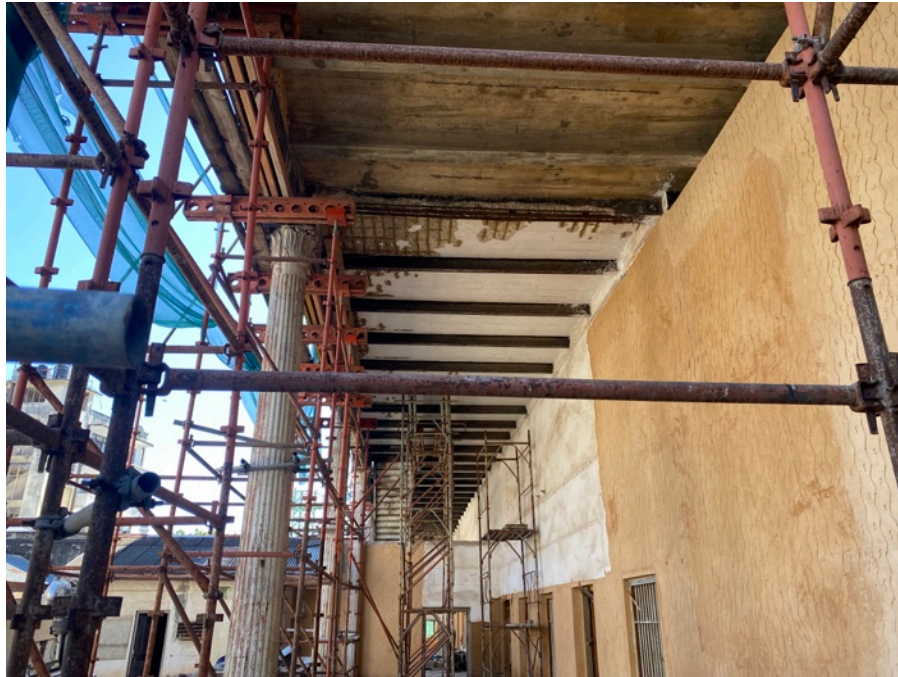
I-section + Timber plants + Mud deck + Marble finish
I-section + Timber planks + Corrugated iron sheet + Concrete + Marble finish
I-section + Timber planks + Corrugated iron sheet + Concrete + Floor screed finish
I-section + Wire mesh + Concrete
I-section + bottom re-bar + Concrete

Figure 4: A deteriorated slab of a walkway in the House of Wonders exposing its only bottom reinforcements (Author).

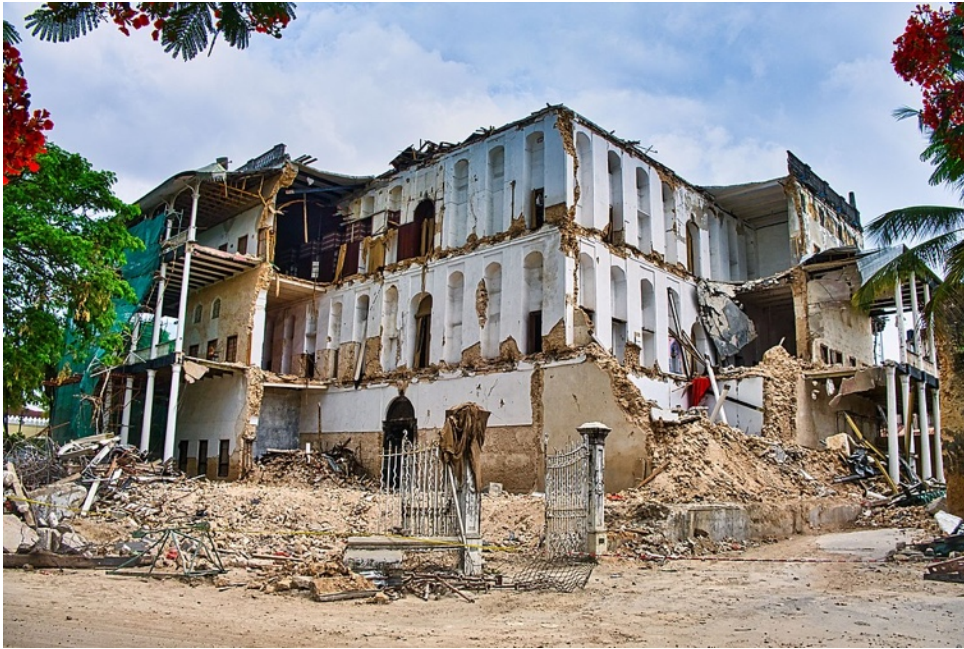
Figure 5: The House of Wonders after 2021 collapses (Courtesy of Abuu Shani).

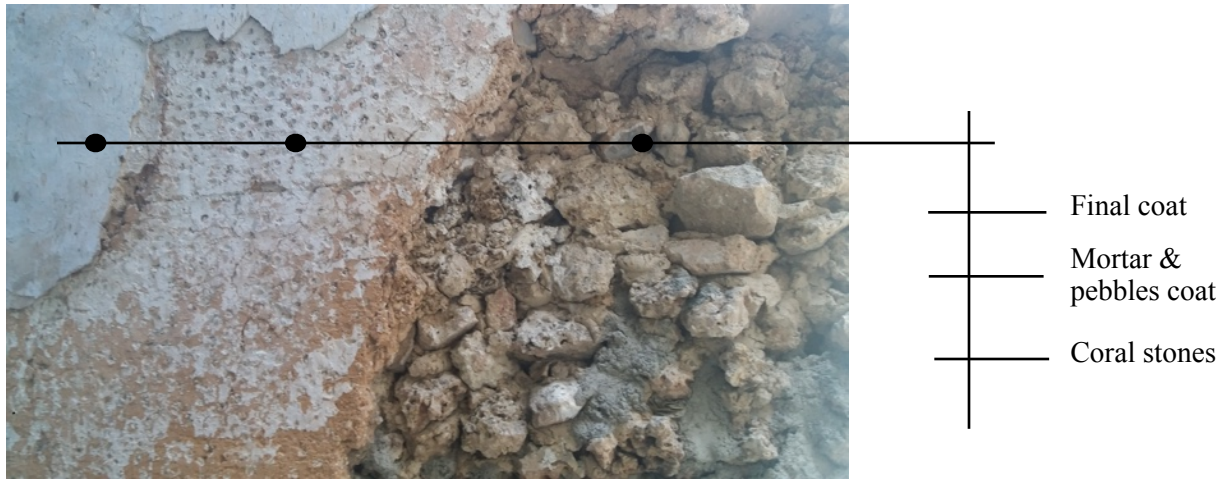
Fig. 8: Layers of plaster work in traditional stone construction (Author)

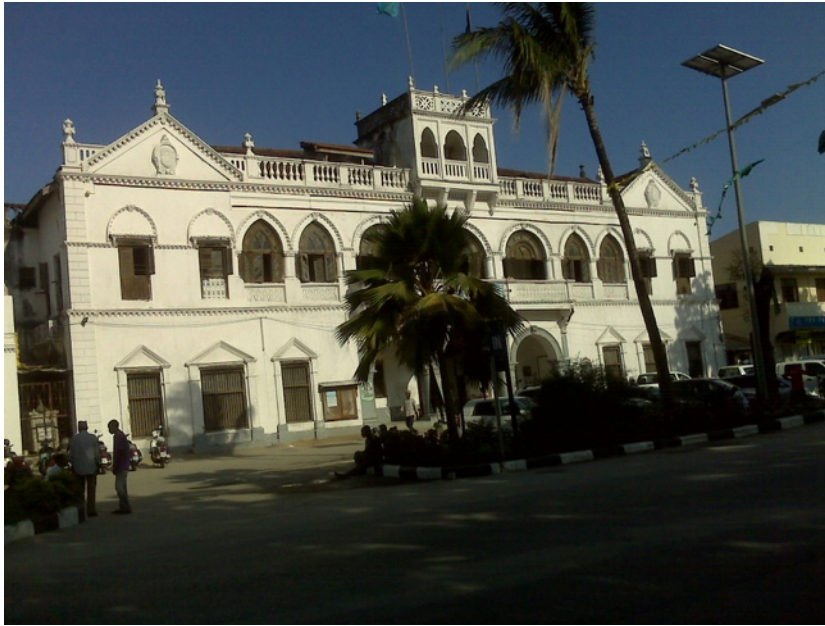
Fig. 10: Front View of Bharmal building (Author)

It has two (2) floors (G+1). The ground floor has six (6) rooms and a toilet while the first floor had ten (10) rooms, a kitchen. The ground floor covers an area of 654 m². The height of the first and second floor is 4.5 m and 4.2 m respectively. Bharmal building features amalgam architecture of Indian taste with flavors of Arabic and European styles. This oriental design has borrowed many of the features of Romanesque architecture composed in a dramatic style. It is the work of Zanzibar's famous architect of the 19th – 20th century, J.H. Sinclair.

The Bharmal building has undergone several renovations in the past. The kind of renovation seems to be limited to patching the plasterwork, floor finish, replacement of rotten elements, painting, and decoration. According to existing archival rent records housed in the building, major structural overhaul may not have been conducted over its nearly 90 years of age. Renovations were also ad-hoc rather than planned. Perhaps the most comprehensive renovation of all is that carried out by a project financed by UN-Habitat between 1989 and 1993. That time there were no contractors specialized in the works therefore, a team of expert architects and craftsmen from the Stone Town Authority, now The Stone Town Conservation & Development of Authority (STCDA) took part in the renovations.

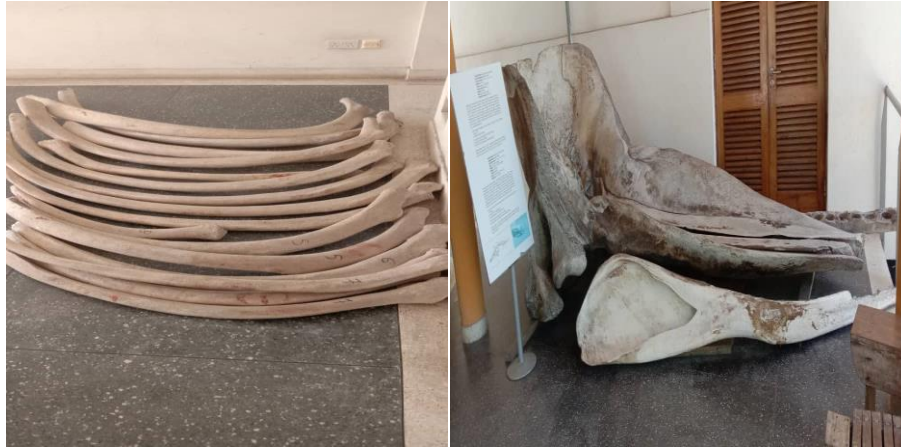
The audit noted that 3 out of 4 visited museums, namely; the National Museum and House of Culture, the Majimaji War Memorial Museum and the Village Museum, had limited space for storage of museums' collections, hence did not ensure the sustainability of the collections.

The audit team visited the National Museum and House of Culture in November 2021 and noted the insufficiency of pertinent storage facilities to accommodate all categories of collections in all six sections, namely; Archaeology, Arts, Biology, Ethnography, History and Palaeontology (see e.g. **Photo 4.1**).

Photo4.1: A sample of museum collections (mammal bones) stored on the floor at the National Museum and House of Culture, Dar Es Salaam
 (Source: Auditors’ Observation, November 2021)

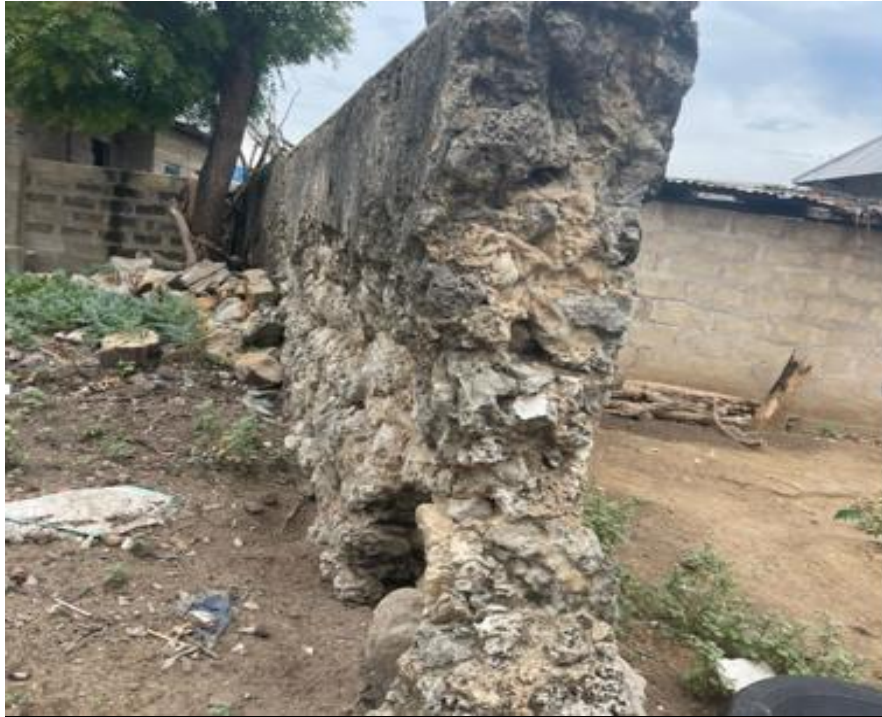
The audit noted unavailability of clear demarcation and regular encroachment of the sites. Out of 12 Cultural Heritage Sites visited by the audit team, 3 heritage sites namely; Mbuamaji, Chongoleani Wall and Kichalikani Wall had no clear demarcations. As a result, the surrounding

community allocated to themselves pieces of land around the Cultural Heritage Sites. The lack of clear demarcations of boundaries for some of the cultural heritage sites was due to inadequate efforts of conducting detailed land survey, following up and monitoring by MNRT on the Heritage Sites.

Photo 4.2: Chongoleani Wall found in between community houses. This picture was taken on 19th January 2022

Lack of clear demarcations of boundaries for some of the cultural heritage sites was due to inadequate efforts of conducting detailed land survey, following up and monitoring by MNRT on the Heritage Sites.

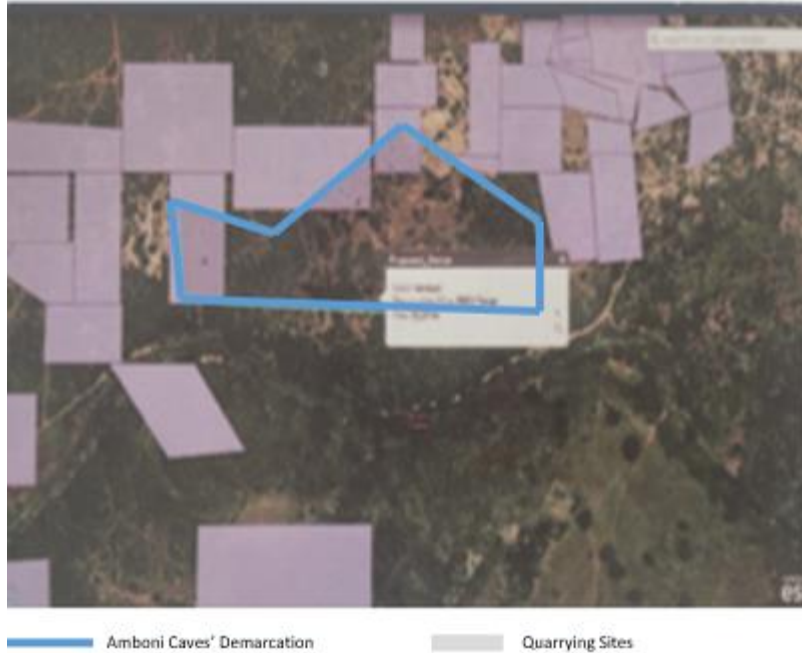
Furthermore, Amboni Caves is surrounded with quarrying mining plots whose owners involve themselves in mining activities which involve dynamite blasting that increases the risk of the collapse of caves due to the massive explosions. The explosions also leave empty pits around the environment which threaten the existence of the caves. The Audit noted that there was no adequate space between the caves and the Mining Plots that would reduce the risk of threatening the existence of the caves.

Figure 4.4: Sketched Map of AmboniCaves Surrounded with Mining Plots Cultural Heritage Site

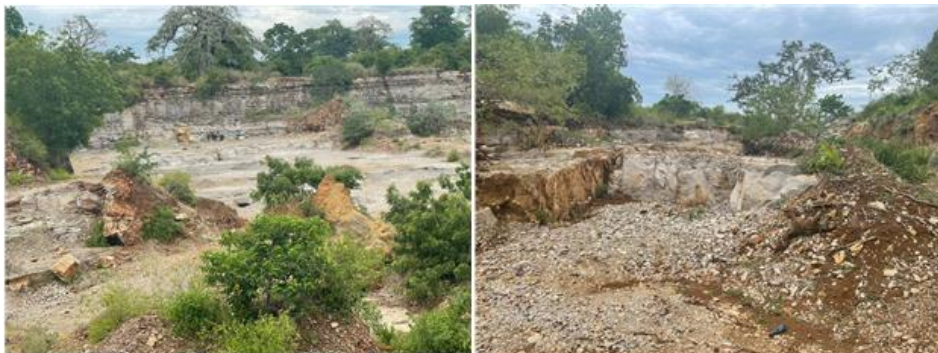
Photo 4.3: Evidence of abandoned Open Pits around the Amboni Caves that threaten existence of the caves

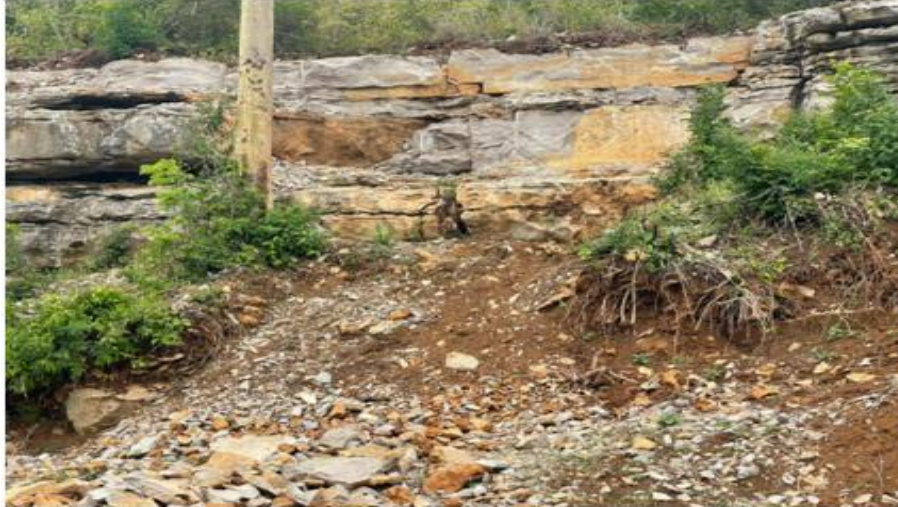
Photo 4.4: Destroyed Number 8 Cave from Quarrying Activities at Amboni Site

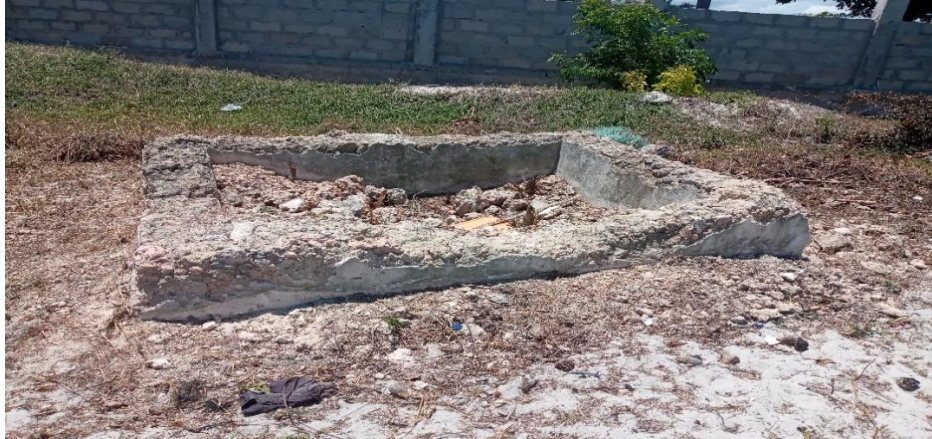
The Director of Antiquities was responsible for the preservation and conservation of all cultural heritage sites. It was however noted that, some Cultural Heritage Sites that were owned by religious institutions and LGAs performed day-to-day preservation of Cultural Heritage Sites independently. The audit noted the absence of staff from the Director of Antiquities to heritage sites that were not owned by DoA.

Consequently, inadequate preservation and conservation of cultural heritage sites led to the deterioration or destruction of gazetted historical buildings as observed in the **Photo 4.5**;

Photo 4.5: Deterioration of graves at Mbuamaji in Dar Es Salaam, November, 2021
